Existing Pile Layout Plan and Damage Key Plan
September 20, 2024

I.L. GROSS
STRUCTURAL
ENGINEERS

PIILING PLAN & DETAILS, STRUCTURAL NOTES
35 UNIT APARTMENT
FOR THE HIGH DEVELOPMENT CO.
TO BE BUILT AT 6TH & BELL STREETS, RAYWALD WASH

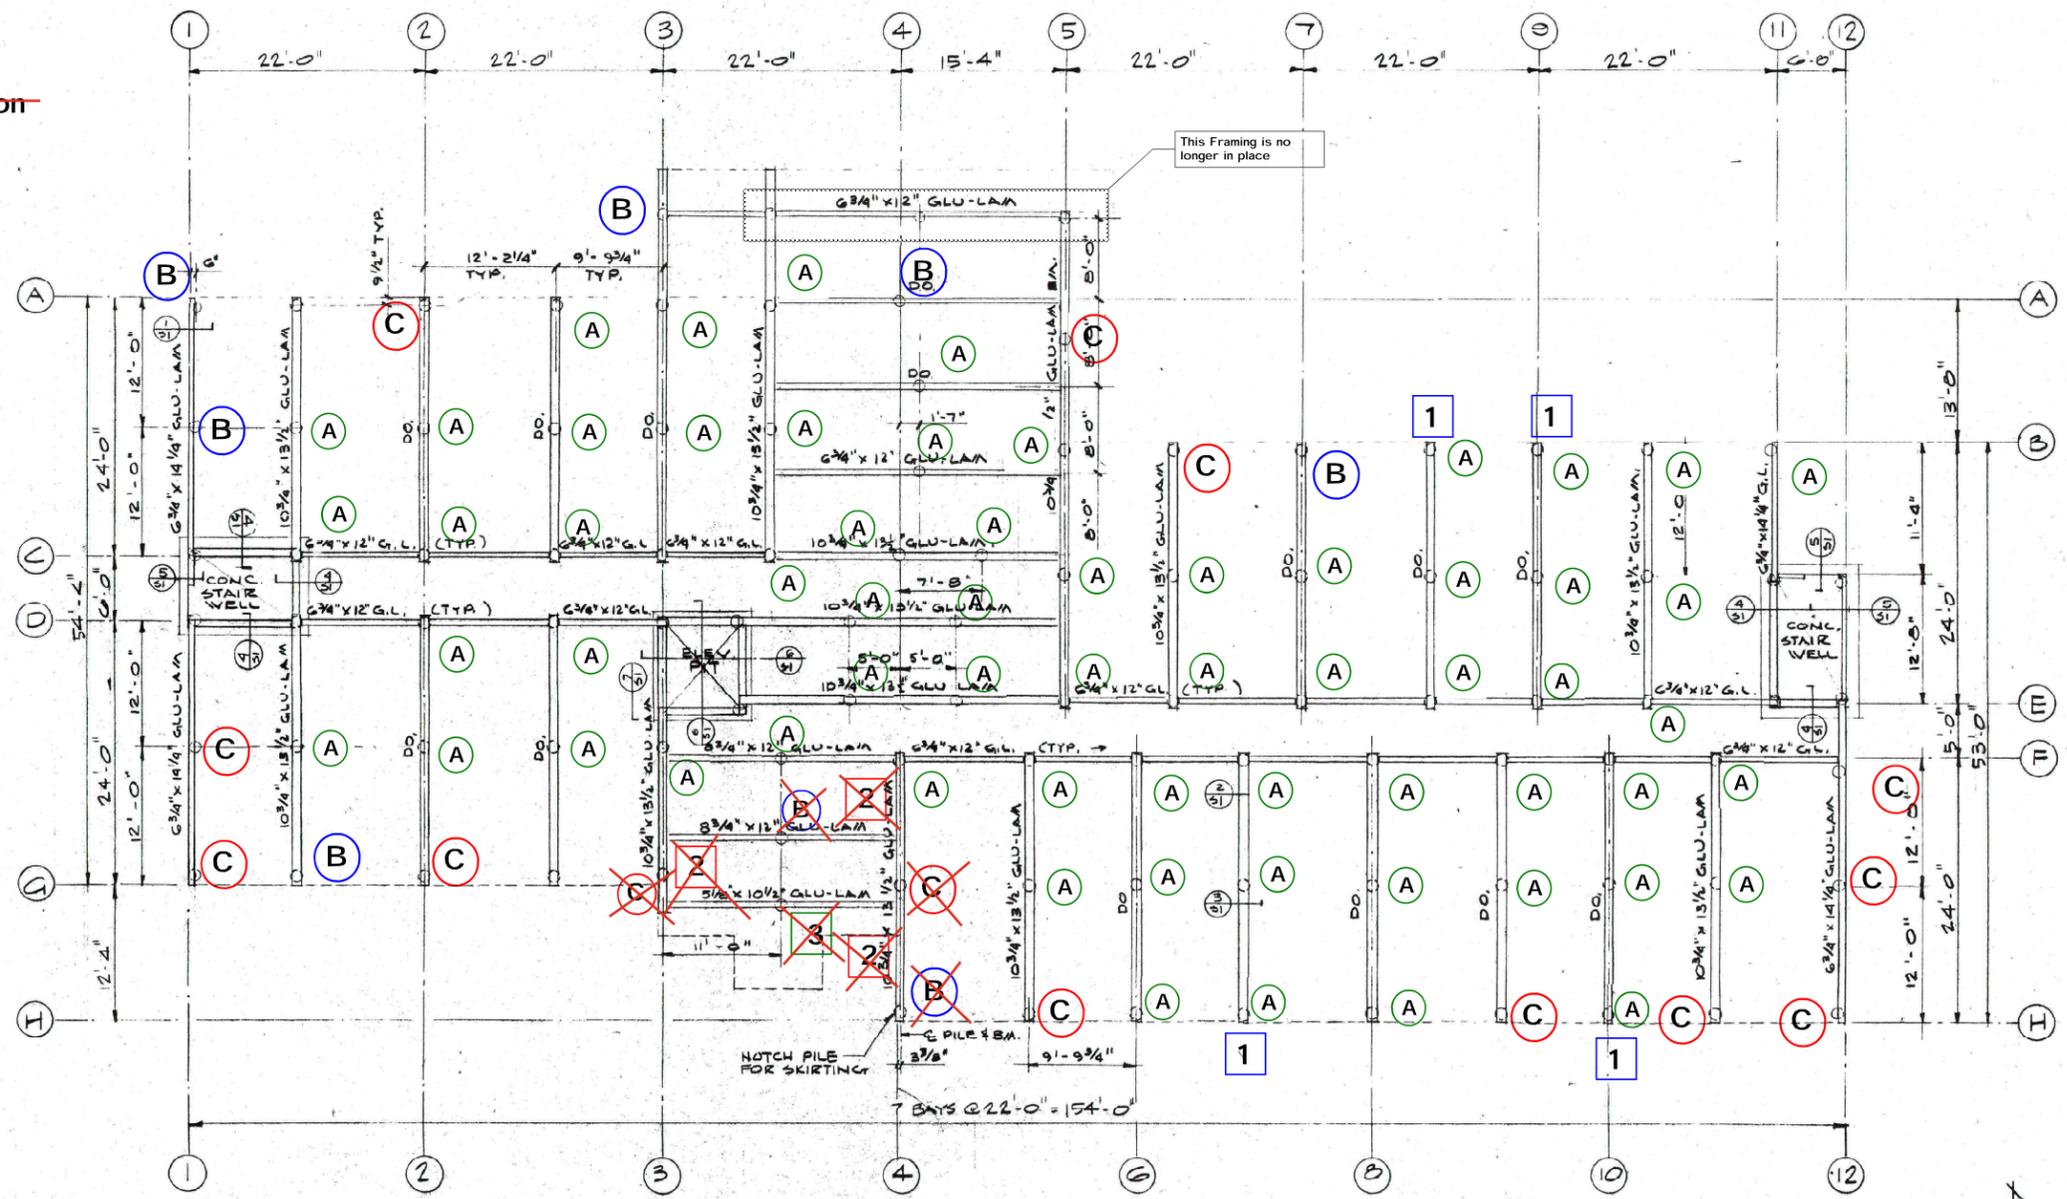
PIILING PLAN
SCALE: 1/8" = 1'-0"

- (A) Pile is OK - Minimal Damage (Typical at all interior piles)
- (B) Pile has Some Rot, mainly above grade
- (C) Pile has significant Rot and likely needs to be replaced

- ~~1 GL Beam is offset from Pile CL~~
- ~~2 Beam has signs of Rot/Deterioration~~
- ~~3 Framing shows signs of Rot/Deterioration~~

BEAM repair completed 10/24
