STRUCTURAL BUILDING EVALUATION

Date: September 20, 2024

Re: Raymond Manor Apartments Evaluation

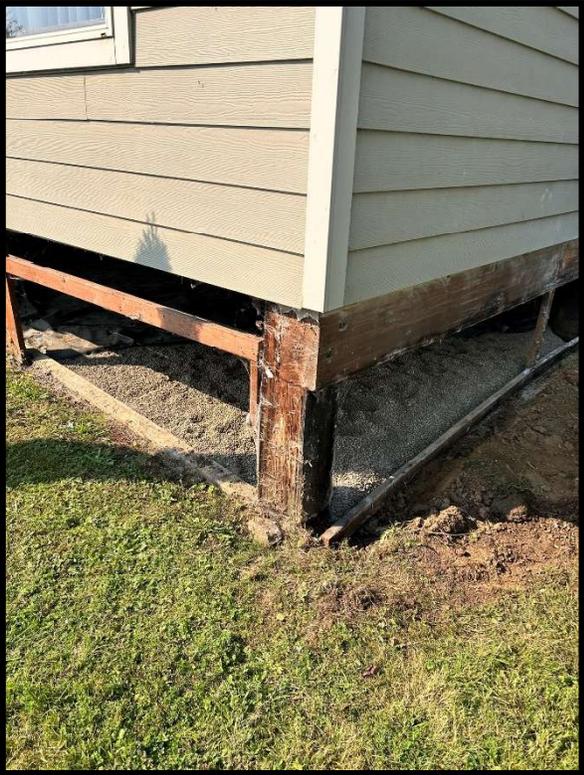
Picture 1 Corner Column at North-East

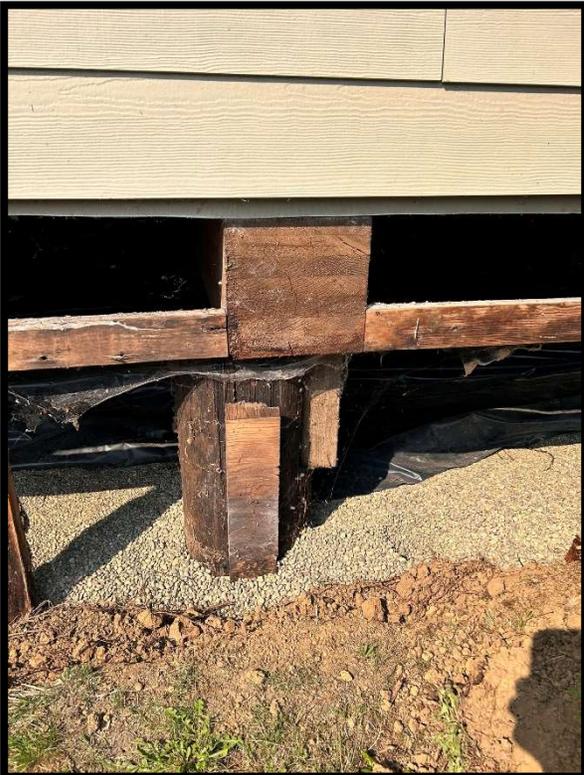
Picture 2 Intermediate Pile at East Side of Raymond Manor

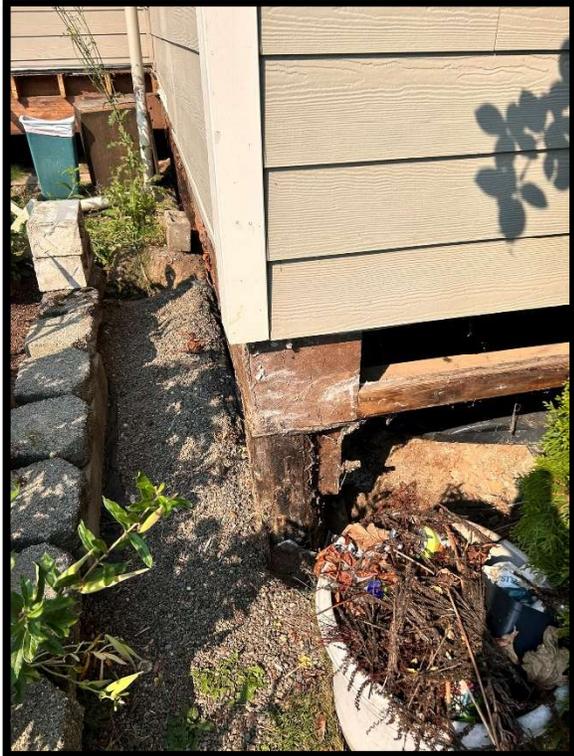
areas around the main entrance adjacent to 6th Street, there are several beams that are damaged or deteriorated. At a minimum, these beams should be treated with a fungal growth inhibitor product to stop the spread of dry rot fungus in the wood, and any beam that has lost more than 10% of it's area should be repaired based per the details attached to this report or replaced with a new beam of an equivalent size.

Picture 3 Pile Near East Entry with Rotten Beam

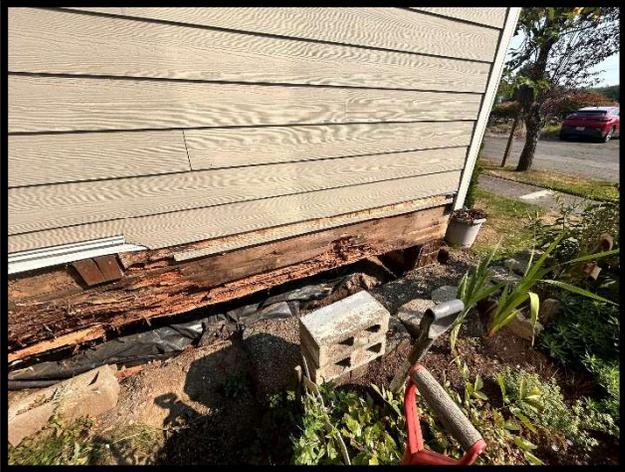
Picture 4 Rotten beam next to East Entrance

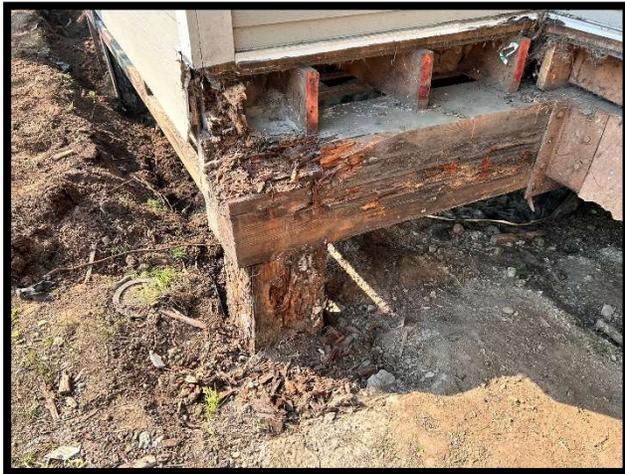
Picture 1 Rotten Beam and Pile at South side of East Entry

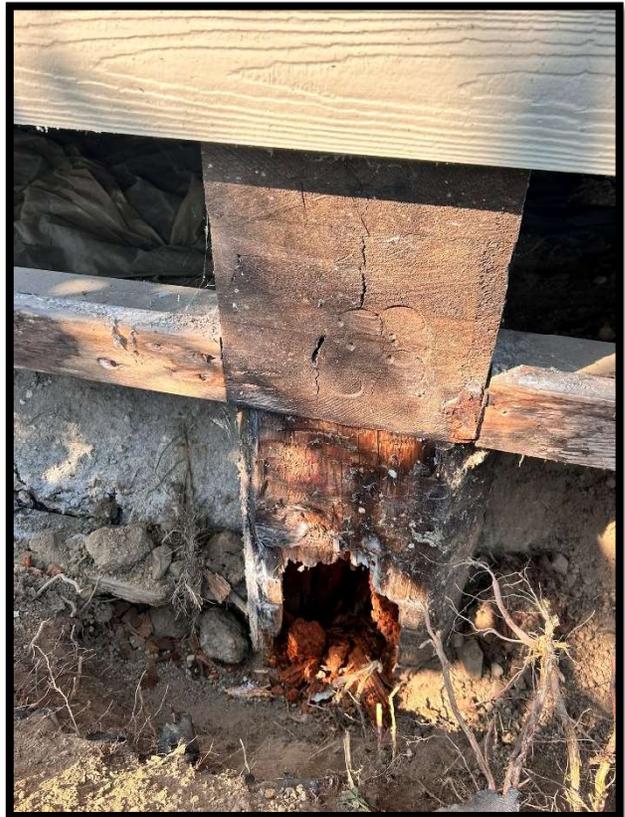
Details in the original construction drawings indicate that the piles at the exterior of the building had their faces notched in order to accommodate the installation of the siding and skirting around the exterior of the building. Unfortunately, at the majority of the piles where this detail was used, the exposure of the un-treated material at the face of the notch has let to significant rot and deterioration. Fortunately, we did not find the same level of deterioration at the piles supporting the interior of the building, which were not notched, so no significant repairs are necessary in the shallow space below the main floor structure. We have attempted to identify which piles are deteriorated on the attached copy of the existing foundation plan, and they should be repaired as follows, based on the severity of the deterioration.

Picture 6 Rotten Pile along South-East Side

- In more moderate cases, the damaged pile may be treated in place to prevent additional deterioration. This treatment should include cutting away all deteriorated portions of the existing pile and treating the existing wood with a fungal growth inhibitor to prevent additional deterioration. Piles with more than 1.5" of deterioration at any face should have supplemental framing installed to replace the deteriorated sections of the pile (see SK-2). The supplemental framing should consist of pressure treated wood, not less than 3.5" thick (4x material), and should be securely attached to the existing pile material.

- Piles with more significant deterioration (more than 4" deep at any face), but where the rot does not extend below the existing exterior grade may be repaired by replacing the rotten pile cap with a new treated timber member of the same size, as shown in SK-3. All of the cut ends of the new and existing piles should be treated with a rot inhibitor, and the joint between the two piles should be sealed with a silicone based sealant to prevent moisture accumulation between the two segments of pile.

- In locations where the deterioration at the pile extends to or below the existing exterior grade, the soil around the pile will need to be excavated in

order to locate the extent of the rot and find sound bearing material in the pile. Then a new concrete cap can be poured around the top of the pile and extended up above grade as shown in SK-4. A new PT 8x10 post will need to be installed to adequately support the existing beams at the main floor.

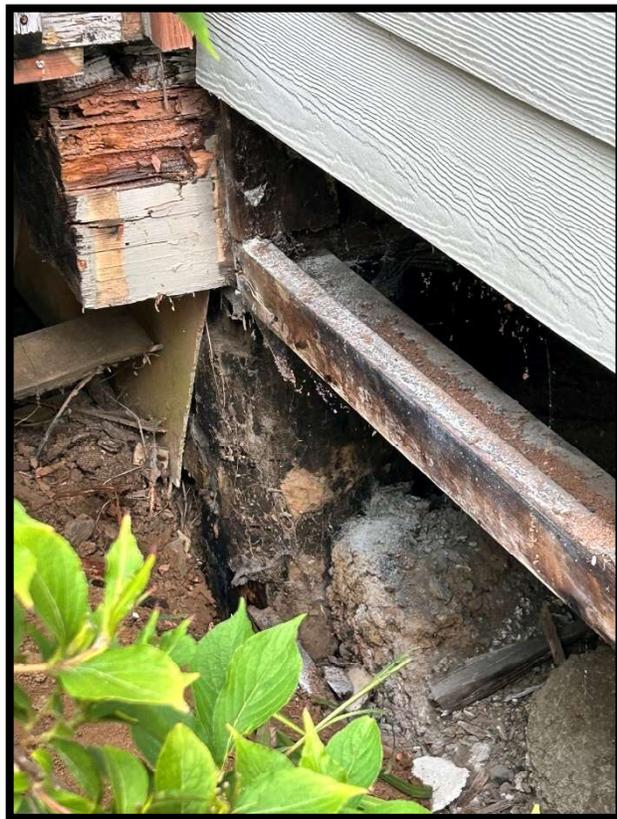
Picture 7 Rot at Back Deck Beams

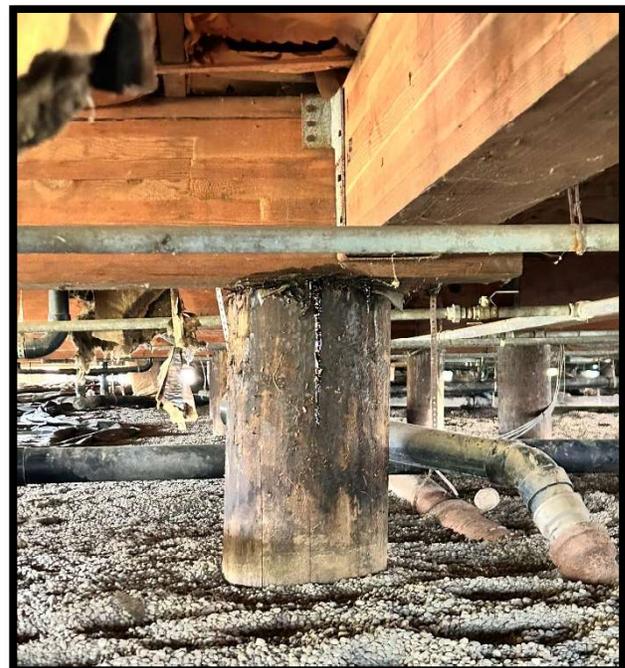
Picture 8 Interior Pile and Beams
