STRUCTURAL BUILDING EVALUATION

Date: September 20, 2024

Re: Raymond Manor Apartments Evaluation

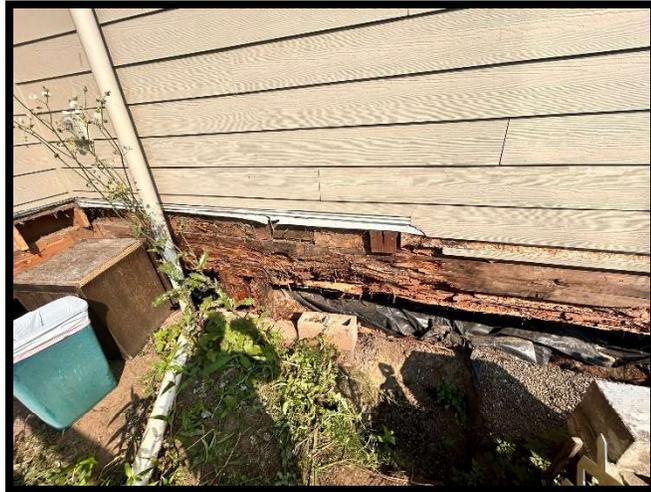
Similar to the upper floors and the roof above, the main floor is framed with typical 2x8 floor joists. However, in place of the bearing walls supporting the upper floors, the main floor is supported on a system of Glu-Laminated beams bearing on the timber pile foundations. In the majority of the areas we were able to observe, these beams appear to be sound and in good condition, but in the

areas around the main entrance adjacent to 6th Street, there are several beams that are damaged or deteriorated. At a minimum, these beams should be treated with a fungal growth inhibitor product to stop the spread of dry rot fungus in the wood, and any beam that has lost more than 10% of it's area should be repaired based per the details attached to this report or replaced with a new beam of an equivalent size.

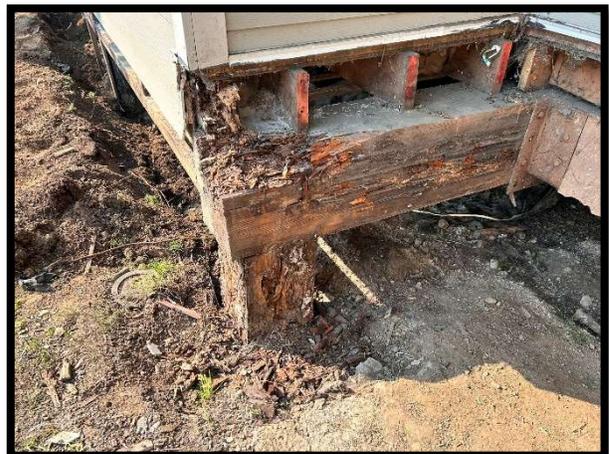
The primary area of concern at Raymond Manor is the existing timber pile foundation system. The building is supported on a series of 96 timber piles, approximately 12" in diameter, driven into the native soils below the building. Although a recent geotechnical evaluation has not been performed for this project site, evaluations completed recently for Willapa Center

(approximately ½ mile away) indicated several feet of loose fill soils below the existing grade, and we would expect to find similar soils below Raymond Manor. Because of this, replacing the deteriorated piles with new conventional foundations is likely not a feasible option.

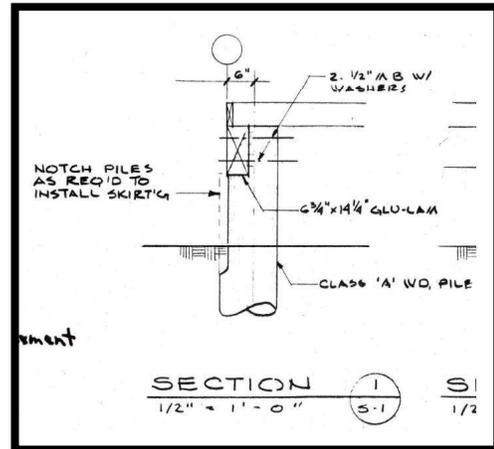
Details in the original construction drawings indicate that the piles at the exterior of the building had their faces notched in order to accommodate the installation of the siding and skirting around the exterior of the building. Unfortunately, at the majority of the piles where this detail was used, the exposure of the un-treated material at the face of the notch has let to significant rot and deterioration. Fortunately, we did not find the same level of deterioration at the piles supporting the interior of the building, which were not notched, so no significant repairs are necessary in the shallow space below the main floor structure. We have attempted to identify which piles are deteriorated on the attached copy of the existing foundation plan, and they should be repaired as follows, based on the severity of the deterioration.

- In more moderate cases, the damaged pile may be treated in place to prevent additional deterioration. This treatment should include cutting away all deteriorated portions of the existing pile and treating the existing wood with a fungal growth inhibitor to prevent additional deterioration. Piles with more than 1.5" of deterioration at any face should have supplemental framing installed to replace the deteriorated sections of the pile (see SK-2). The supplemental framing should consist of pressure treated wood, not less than 3.5" thick (4x material), and should be securely attached to the existing pile material.

- Piles with more significant deterioration (more than 4" deep at any face), but where the rot does not extend below the existing exterior grade may be repaired by replacing the rotten pile cap with a new treated timber member of the same size, as shown in SK-3. All of the cut ends of the new and existing piles should be treated with a rot inhibitor, and the joint between the two piles should be sealed with a silicone based sealant to prevent moisture accumulation between the two segments of pile.

- In locations where the deterioration at the pile extends to or below the existing exterior grade, the soil around the pile will need to be excavated in

order to locate the extent of the rot and find sound bearing material in the pile. Then a new concrete cap can be poured around the top of the pile and extended up above grade as shown in SK-4. A new PT 8x10 post will need to be installed to adequately support the existing beams at the main floor.
